# SUZUKI PROPERTY ECOLOGICAL ASSESSMENT

## Bainbridge Island, Washington

Prepared for  
City of Bainbridge Island

March 2017

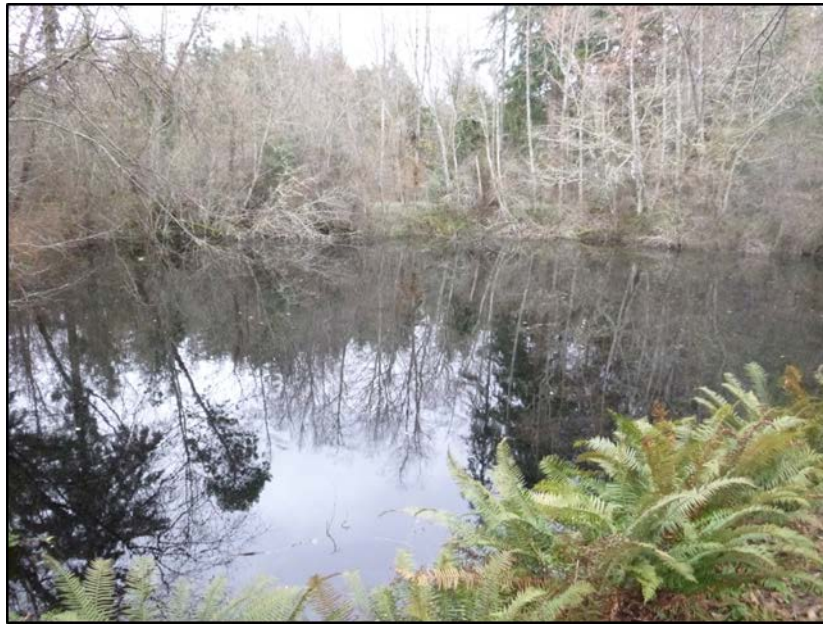
***Human-Created Pond***

As shown in Figure 3, an approximately 0.5-acre human-created pond is located on the south property boundary. The pond is surrounded by an earthen berm, and is likely maintained by a high groundwater table and/or a clay lining at the bottom of the pond. A Douglas fir tree rooted within the berm was determined to be between 71 and 76 years old (see Appendix A for details), indicating that the pond was likely constructed in the mid-20<sup>th</sup> century.

The pond is permanently flooded and approximately 10 feet deep, with a seasonal variation of 3 to 4 feet (Bainbridge Island, 2016). Vegetation in the pond includes duckweed, water parsley, and yellow-flag iris. Despite the fact that the pond is a human-made feature, it provides habitat for a variety of species that rely on open water habitat for all or a portion of their life cycle, such as amphibians and many insects (Sheldon et al., 2005). Other species, such as deer and herons, use open water areas for obtaining some life requirements (e.g., sources of prey and drinking water). The close proximity and uninterrupted connection between the pond and the adjacent forest habitat support both the overall wildlife populations and biodiversity on the property.

We recommend avoiding disturbance to the pond, given its importance as a habitat feature on the property. Additionally, we recommend maintaining a protective buffer of existing native vegetation around the pond. Ideally, the pond buffer would be a component of the habitat corridor across the southern portion of the site (see Section 4.3.3 below).

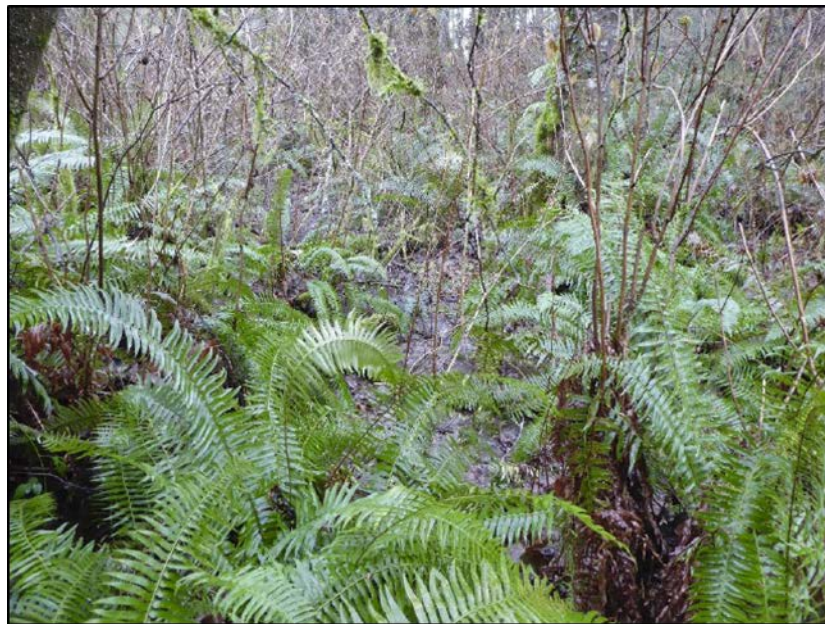
***Potential Wetland Area 1***

Potential Wetland Area 1 is a depressional feature near the center of the property. The dominant vegetation in the area is red alder trees, with some scattered western red cedar trees. The understory is dominated by salmonberry, with patches of salal, swordfern, and trailing blackberry, primarily on the fringes of the wetland area.

During the December 15, 2016 site visit, shallow ponded water was observed in the middle of the potential wetland area. The area is isolated (i.e., there is no obvious surface water outlet). During and shortly after rain events, the area reportedly contains standing water up to 6 inches deep (C. Kratzer, personal communication, December 15, 2016). No standing water is present during drier periods; surface water infiltrates into the soil fairly rapidly after rain events.

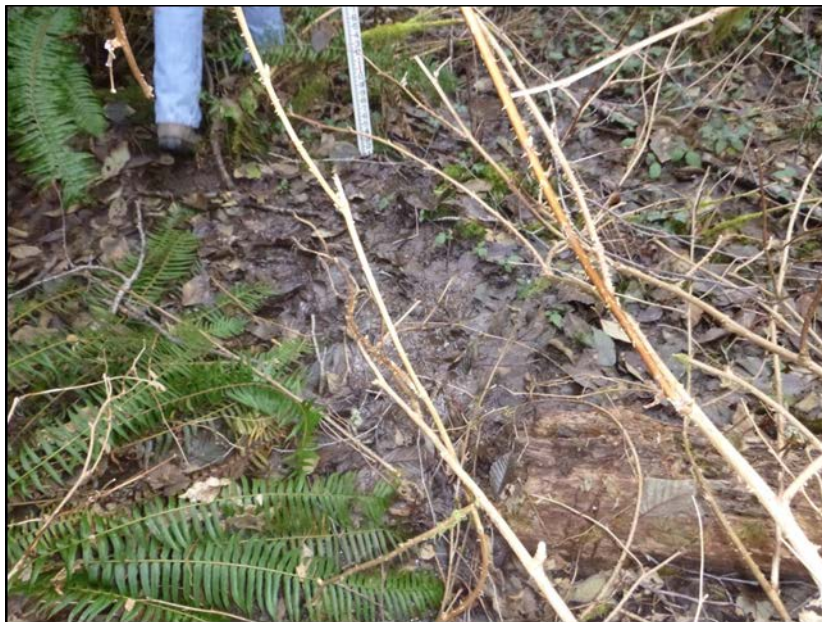
*Potential Wetland Area 2*

Potential Wetland Area 2 is a linear swale feature in the east-central portion of the property. The area slopes to the west and drains into the ditch along Sportsman Club Road NE (see Section 3.3.5). The dominant vegetation in the area is primarily red alder trees with an understory of salmonberry, with some scattered patches of swordfern, trailing blackberry, and red elderberry along the potential wetland area boundary. During the December 15, 2016 site visit, areas of soil saturation and water seeping from the hillside were observed.

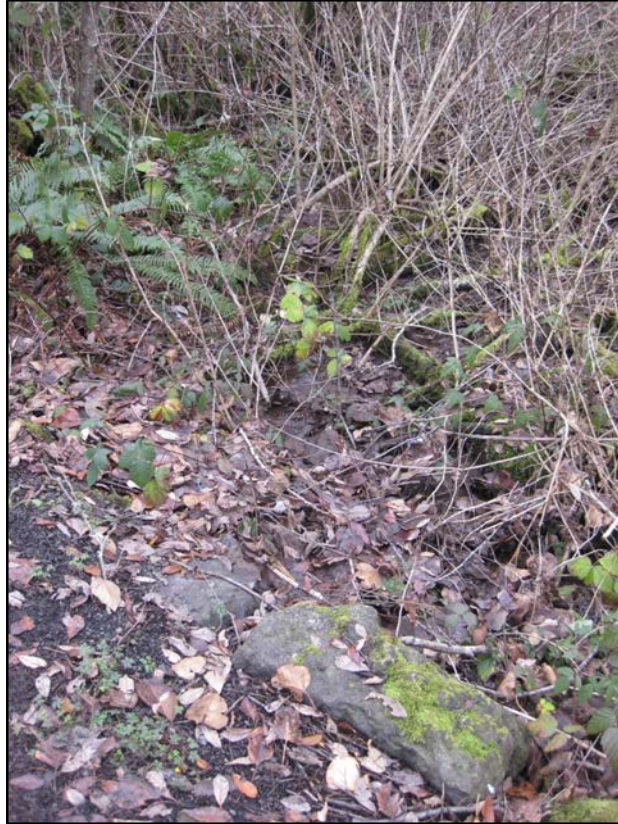
***Potential Wetland Area 3***

Potential Wetland Area 3 is a depressional feature near the southwest corner of the property. The area drains south into the ditch along Sportsman Club Road NE (see Section 3.3.5). The dominant vegetation in the area is primarily red alder trees and mature willows, with an understory of salmonberry and soft rush. During the December 15, 2016 site visit, ponding was observed in the area, and water was observed flowing out of the area into the adjacent ditch.

It appears that a portion of the wetland is seasonally flooded (meaning that the observed ponding persists for at least two consecutive months out of the year). As opposed to the other two potential wetland areas identified on the property, Potential Wetland Area 3 may provide breeding habitat for amphibians.

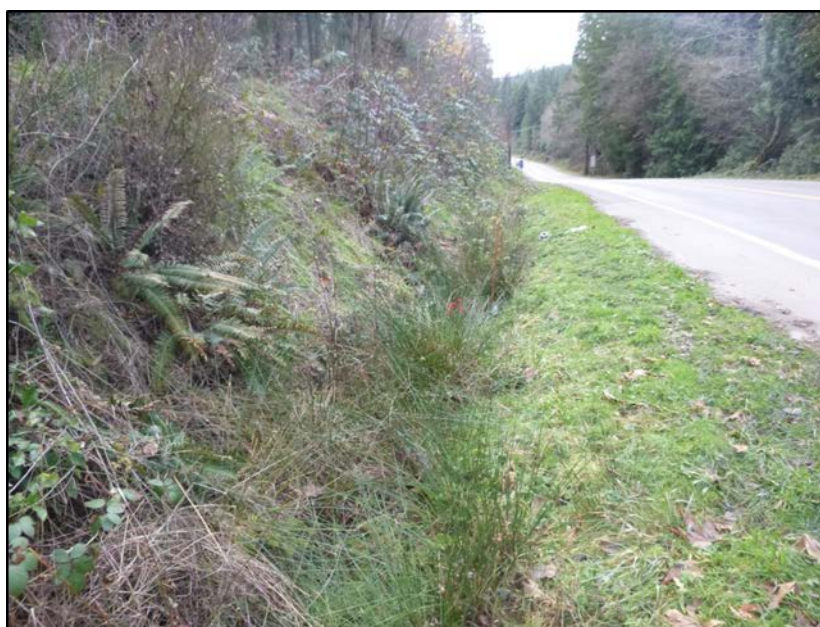
In the immediate vicinity of the property, the drainage feature appears to be a human-created ditch with the primary purpose of intercepting and conveying stormwater runoff from Sportsman Club Road NE. The channel is heavily vegetated with blackberry, rushes, grasses, and forbs forming a thick mat of vegetation within the bottom and sides of the channel. Patches of swordfern, an upland plant, also extend adjacent and into the channel. The substrate within the ditch is predominantly compacted organic soil and root material, with little natural cobble or gravel observed (some irregular and small patches of angular quarry spalls were observed).

*Drainage ditch west of the Suzuki Property*

Based on the observed channel, habitat, and hydrology within the drainage feature, it appears that the portion of the drainage feature in the immediate vicinity of the property should not be considered a stream, but rather a manmade stormwater conveyance feature. Drainage appears to come primarily from roadway stormwater runoff, and no suitable habitat for fish species is present within the homogenous, linear channel. Downstream of the property, it is likely that the contributing basin area is large enough to create and maintain a stream channel, but these conditions do not occur in the immediate vicinity of the property.

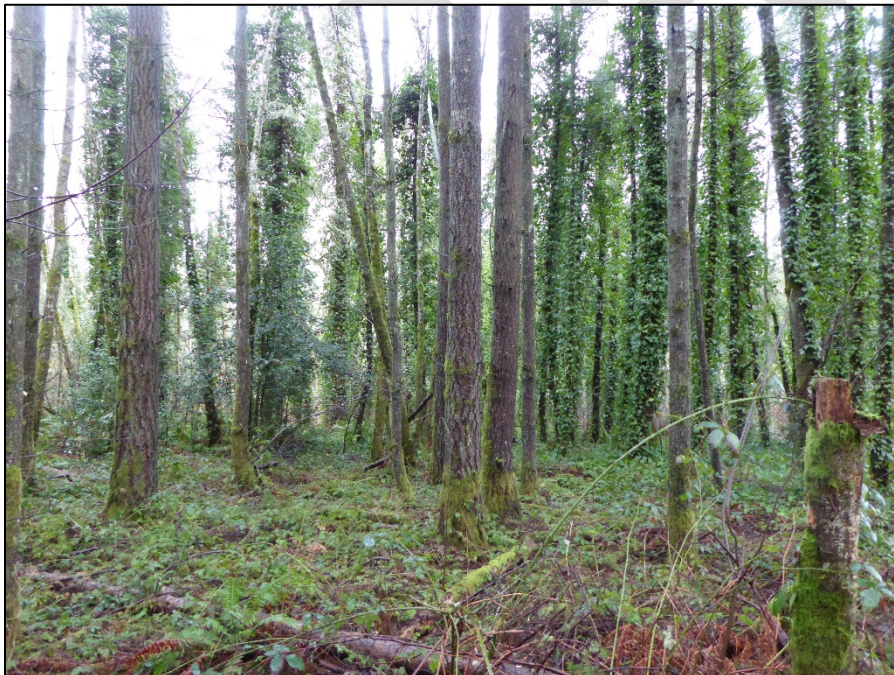
Photo 2: Invasive ivy climbing on trees in the western portion of the Type 1 area.

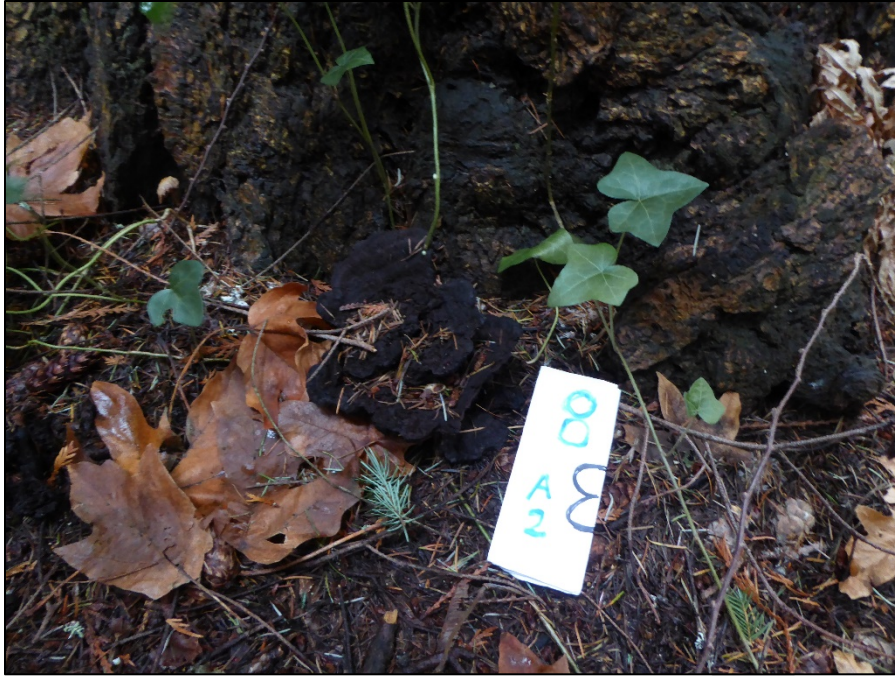
Photo 13: Fruiting body of decay causing fungi, *Phaeolus schweinitzii*, at the base of tree 9. This fungus is typical of older fir trees and is not a major concern at this time.

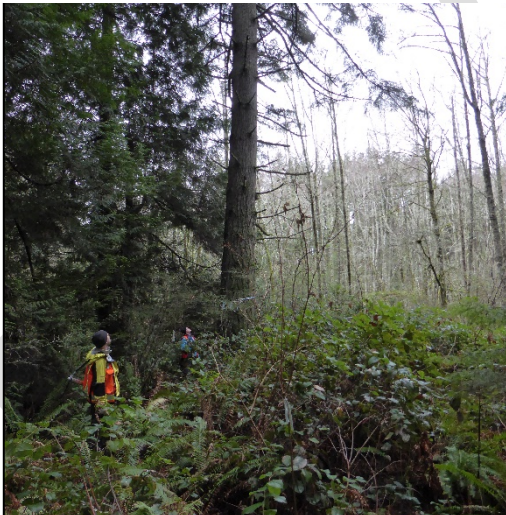
Photo 14: Base of tree 13. This tree had low growing branches, likely due to the increased sun exposure from the forest gap to the north. This is the second oldest tree we assessed, aging between 122 to 127 years old.

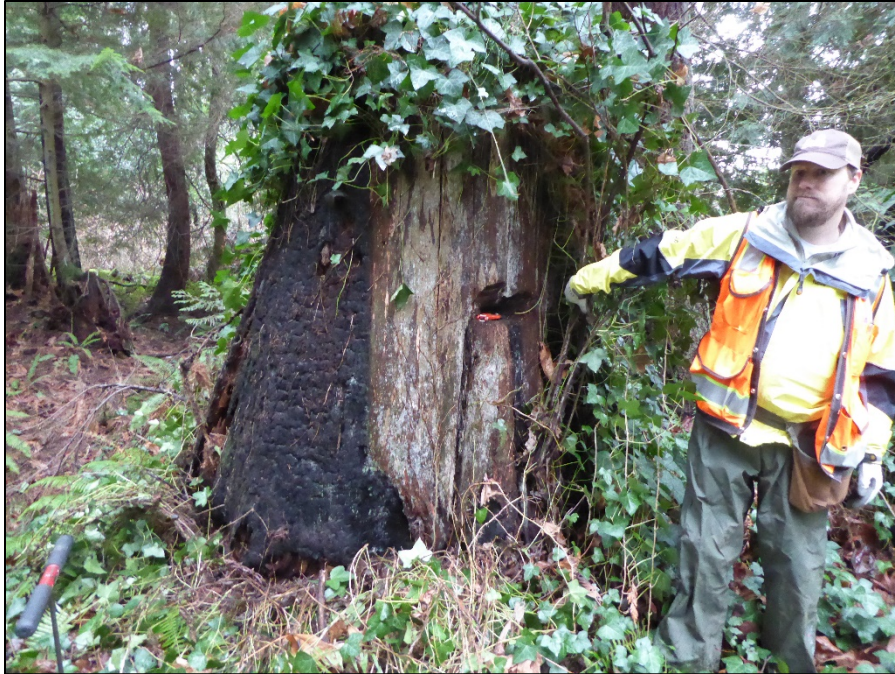
Photo 15: Photo of old cedar stump with springboard notches. This tree was likely logged in the late 1800s.
