# Island Center Subarea Planning Process Steering Committee Meeting

**June 20, 2018 6:30 – 8:30 PM**

# SPRINGBROOK CREEK WATERSHED ASSESSMENT PROJECT

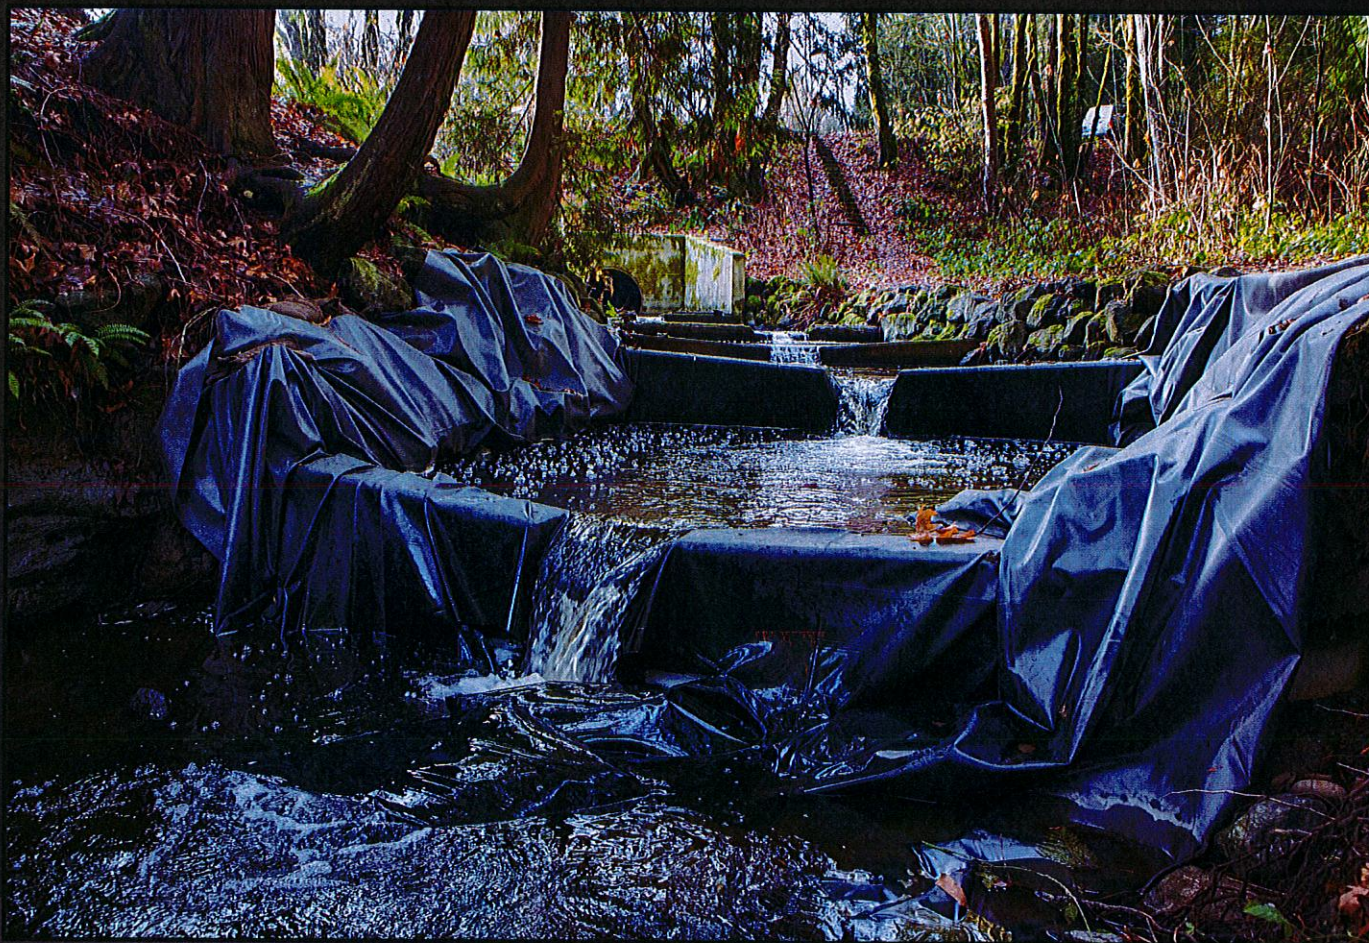
# Fletcher Bay Rd. NE

3.6 miles  
of type F habitat above the crossing

33% passable for adult salmonids (vertical drop) - WFC 2017

0% passable for juvenile salmonids, brook lamprey, sculpins, and stickleback.  
Series of 8 weirs, (5 below the culvert, 3 above) the lower weir is failing.

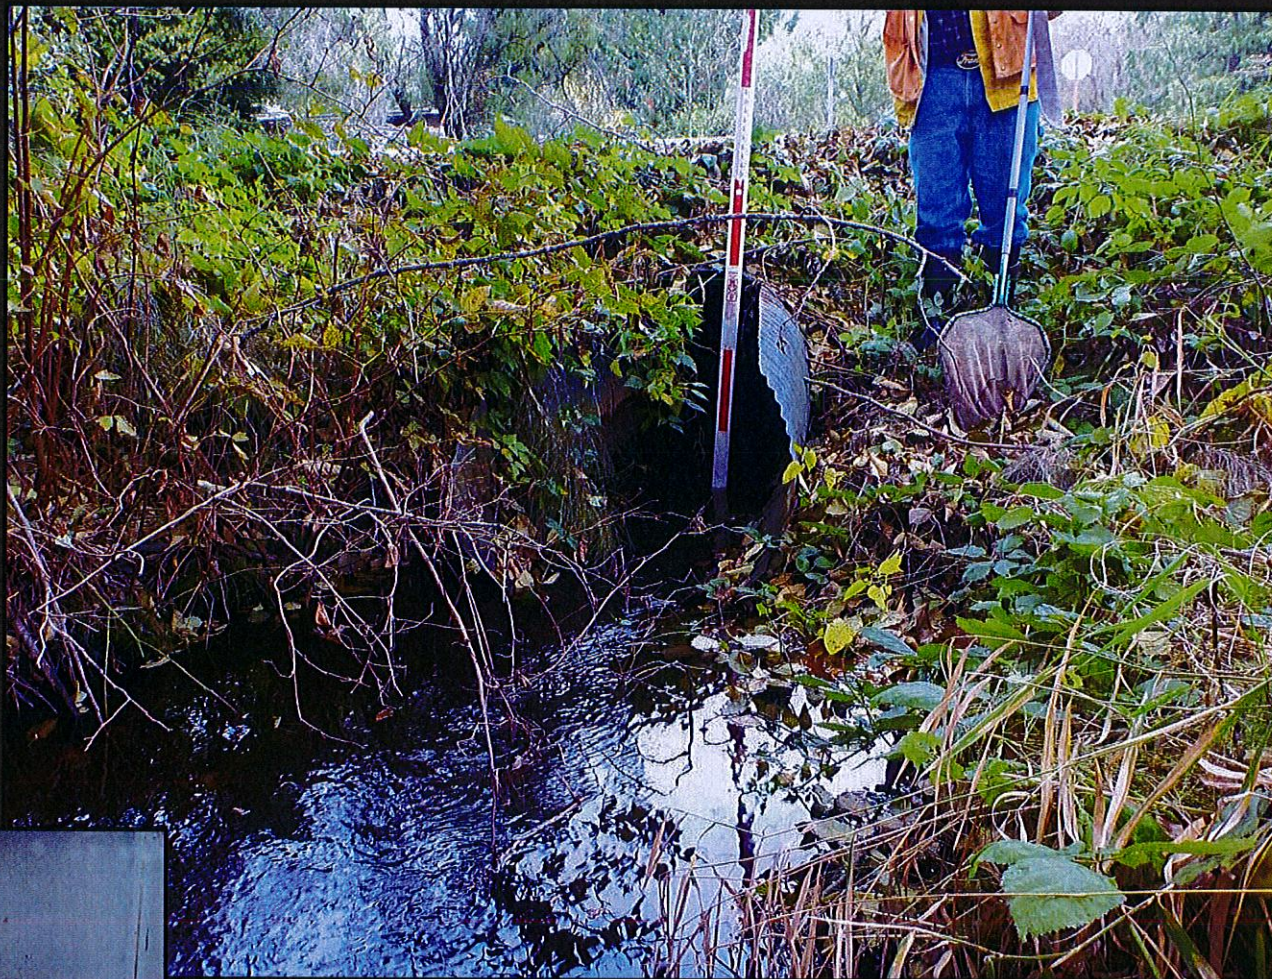
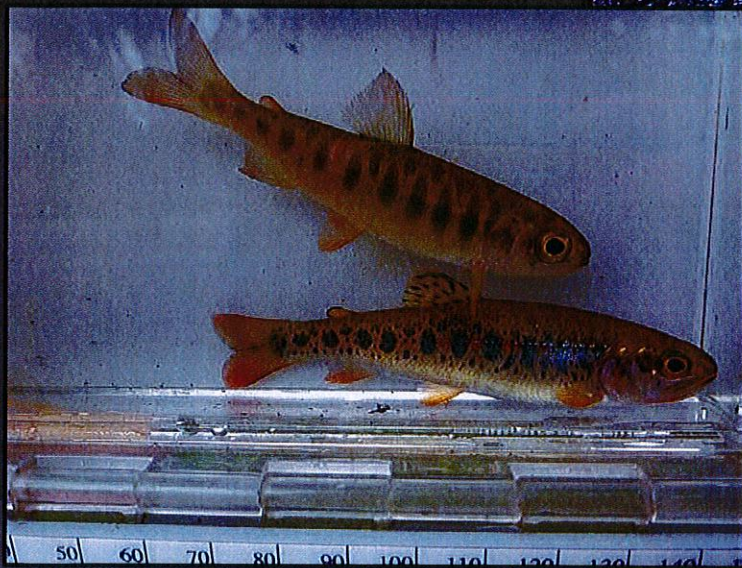
67% passable  
(slope) – FPF 2008

Culvert rusting  
through at outlet

Channel ditched  
along NE High  
School Rd. above  
the crossing

Coho and cutthroat trout netted  
at culvert outlet

Replace culvert

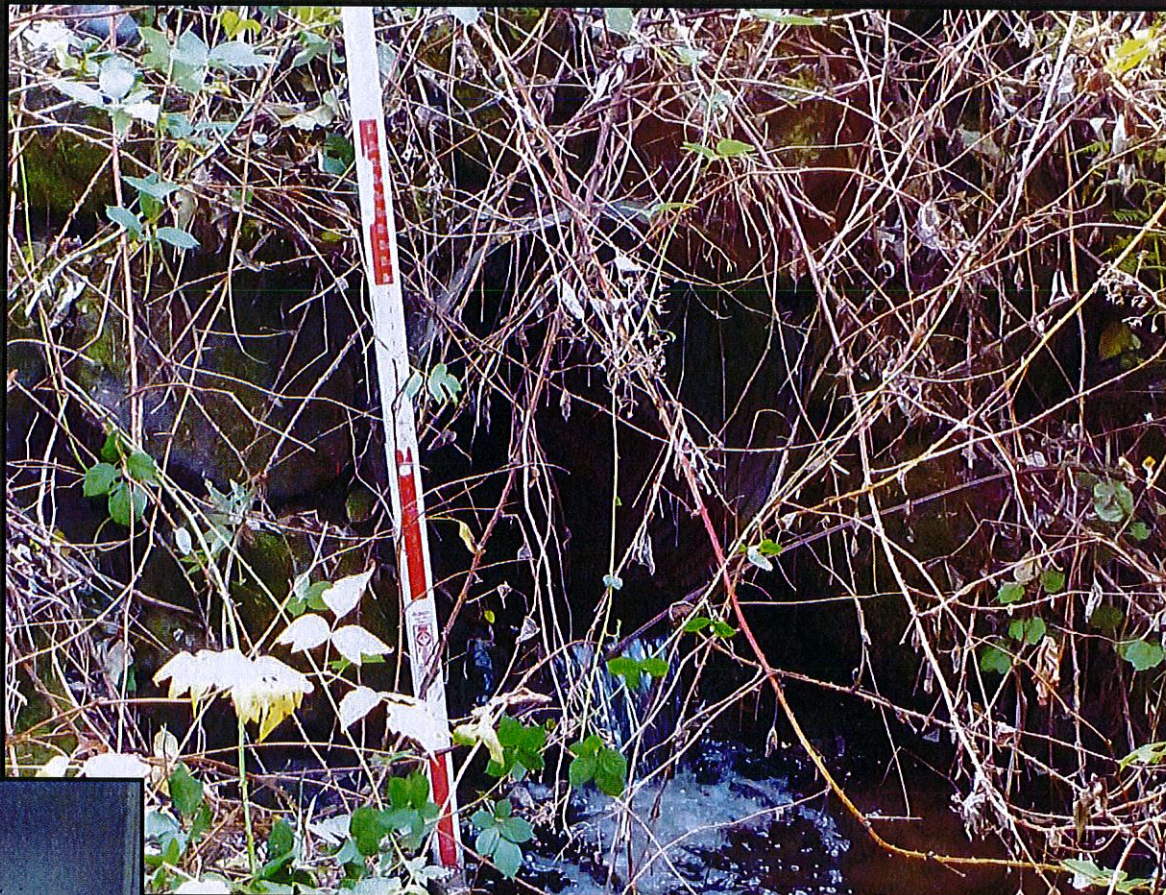
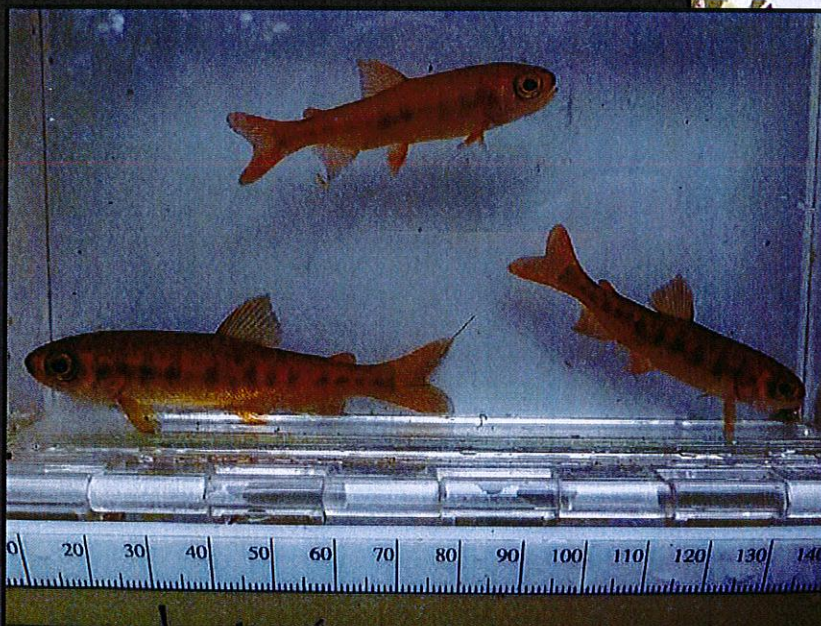
67% passable  
(vertical drop) – WDFW  
2014

Channel ditched along  
NE High School Rd. below  
the crossing

Coho netted above the culvert

Replace culvert
