# City of Bainbridge Island

| Subject: 7:15 PM Historic Preservation Commission Recommendations:<br>Suyematsu-Bentryn Family Farms, AB 16-037 - Planning | Date: 3/15/2016 |

# Suyematsu Farm Historic Structure Report and Feasibility Study

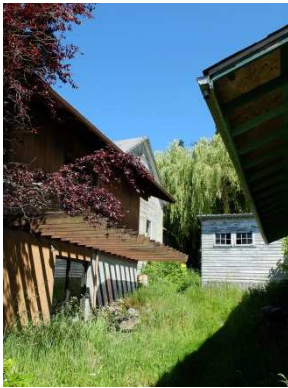
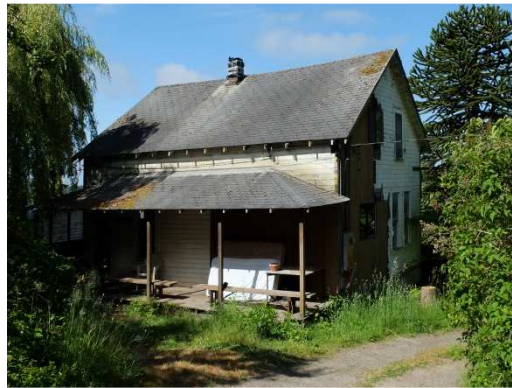
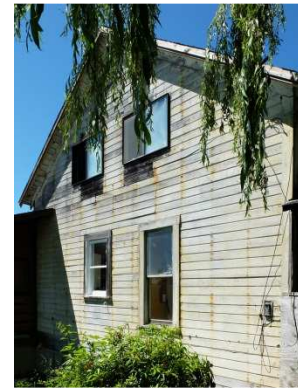
## **No. 1 Farmhouse**

Fig.8a 1970s Addition.

Fig. 8b. NW elevation with mixed siding.

Fig.8c. Window types.

The house itself is good condition primarily due to the grouted concrete block foundation installed in the 1970s, which stabilized and united the two structures. There is little evidence of water leakage except through a masonry chimney flue. The newer aluminum windows invariably have gaps around the openings and should be replaced with the original double-hung wood windows stored in the sheds. The stairway needs to be braced and repaired for code conformance. The electrical and water systems should be checked for life safety and health code conformance.

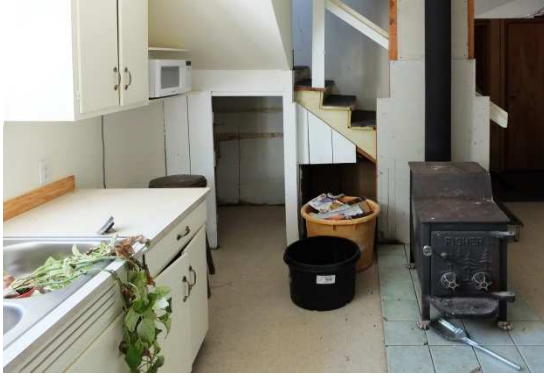
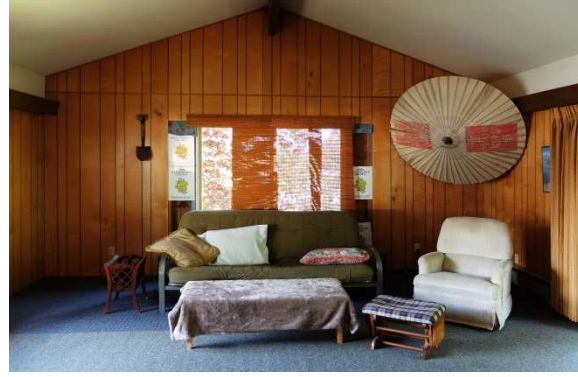
Fig. 8e. Kitchen cabinets and stairway.

Fig. 8f. 1970s great room addition.

The interior of the house retains much of its original unembellished character, including kitchen cabinets built by Akio and his brother at the school wood shop as a Mother's Day gift to their mother (Garfunkel 2013). In 1971, the family put a one-story addition plus basement on the west elevation (Kitsap County 2014). The addition expresses the frugality of the farmer's use of readily available materials of a more modern design. The economy used to build and repair buildings within the complex exhibits the practical approach to farm management.

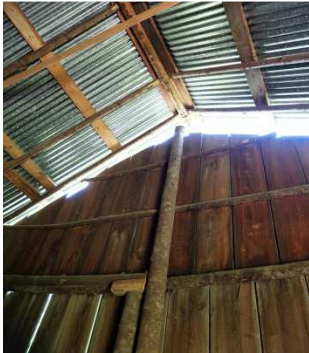
Fig.9a. Gap at ridge.

The barn has shifted on its foundation over time and some of the pole structures are consequently twisted and deformed. Some of the original foundation pole columns and beams need to be replaced due to rot. However, the original basic structural system is intact and only needs some replacement pieces and adjustment. The walls and roof supported by the foundation have deflected and need to be replaced and braced. This is

especially true on the north wall (Fig.9a) where the roof is floating free of the wall. When the foundation is leveled and reinforced, the walls and roof structure will be reconfigured to their original design. The poles or any other members that have deflected over time need to be replaced. Almost all of the existing siding, skirting, floor planks and barn doors can be reused.

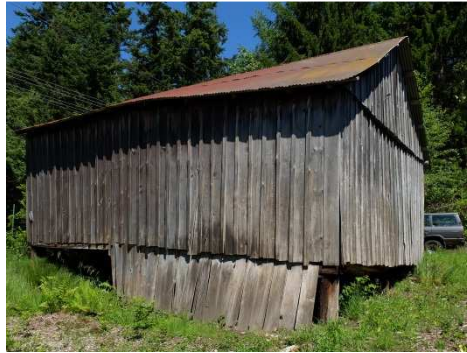
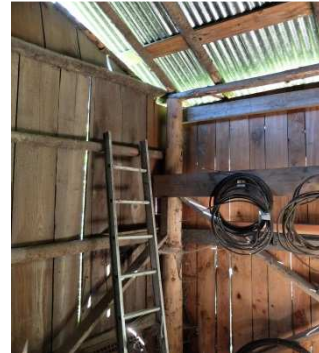
Fig. 9b. West elevation.

Fig. 9c. Log column.

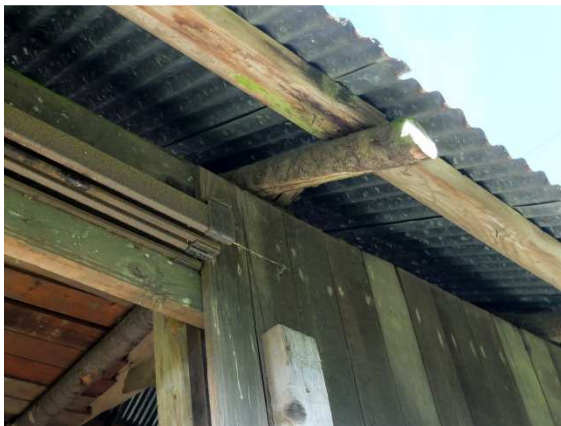
Fig.9d. Pole rafters and corrugated roof.

The gable roof barn is 24 x 30 feet long, oriented north-south, and is broken into three 10 x 24 feet long bays on the east elevation. The foundation consists of imbedded 16 inch diameter treated poles (that vary in length) one on each corner, one at each exterior midpoint and one in the middle for a total of nine column supports. Three large half-round 18 inch diameter pole beams connect the columns in the north-south direction. Logs ranging from 6 to 8 inches in diameter are placed at approximately 2 feet on center and connect the half-round beams in the east-west direction. The logs support 2 x 8 inch and 2 x 12 inch planks which make up the floor of the barn.

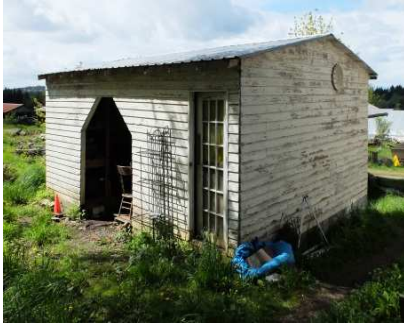
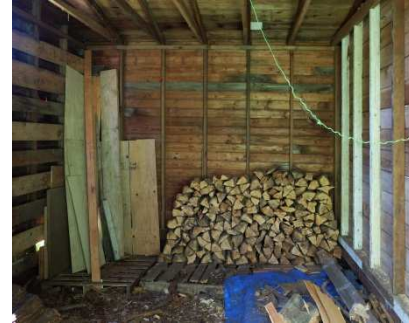
### ***No. 5 Office and Storage Building***

Fig. 11a. Northeast elevation.

Fig. 11c. Storage area.

The structure is in good condition and only requires regular maintenance.

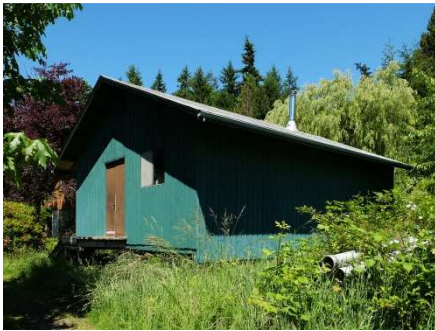
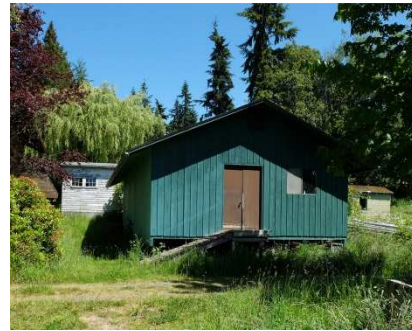
#### **No. 6 Berry Shed**

Fig. 12a. SW elevation.

Fig. 12c. West elevation.

The structure is in good condition and only requires regular maintenance.

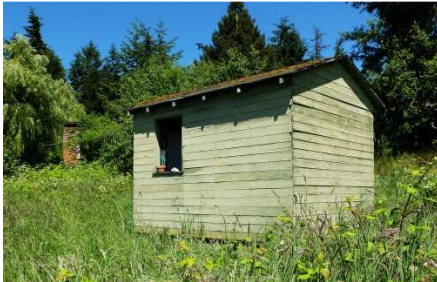
Fig. 13a. SW elevation.

The shower shed is a simple wood frame structure feet 8 x 10 feet long. It is oriented north-south and has a 4:12 slope gable roof clad with asphalt shingles. It is constructed with 2 x 4 inch studs at 2 feet on center. The roof is supported by 2 x 4 inch rafters and cross ties spaced 2 feet on center and covered with horizontal 1 x 6 inch boards. The exterior walls are clad with 1 x 6 inch shi lap wood siding. The door on the north side opens to a room with a 2'8" x 2'8" metal shower enclosure and water heater. The foundation is not imbedded into the ground and sits one foot above grade.

The unstable foundation has caused the building to rack and has jammed the door in an open position. Simple restoration of the foundation and leveling will ensure years of use.

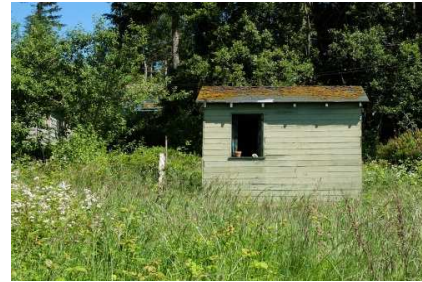
Fig. 13c. West elevation.

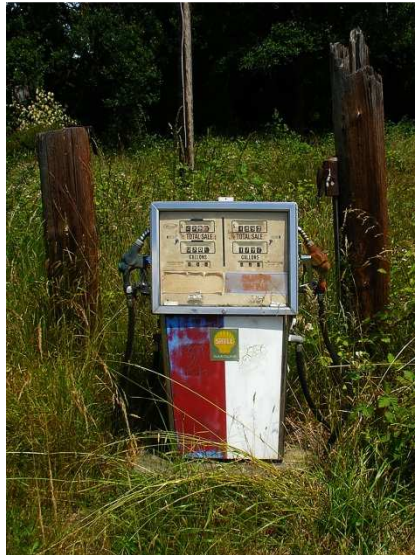
Fig. 14 . West elevation.

The pump has not been used for many years, but appears to be in good condition.

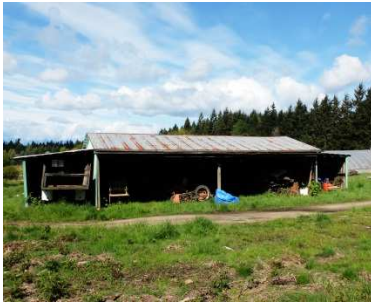
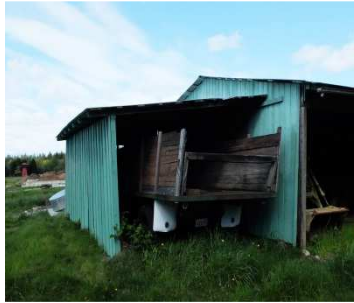
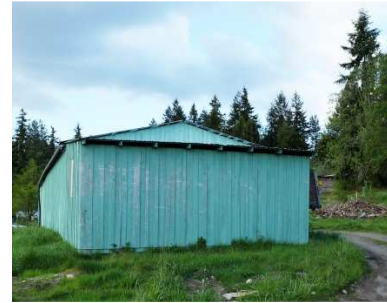
## No. 10 Shed 1

Fig. 15a. East elevation.

Fig. 15b. End bay storage.

Fig. 15c. South elevation.

The structure is in good condition and only requires regular maintenance.

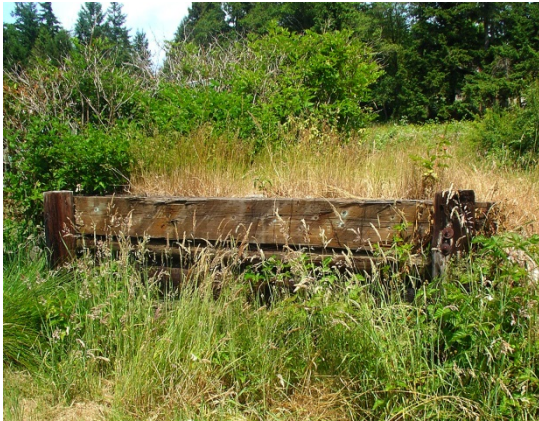
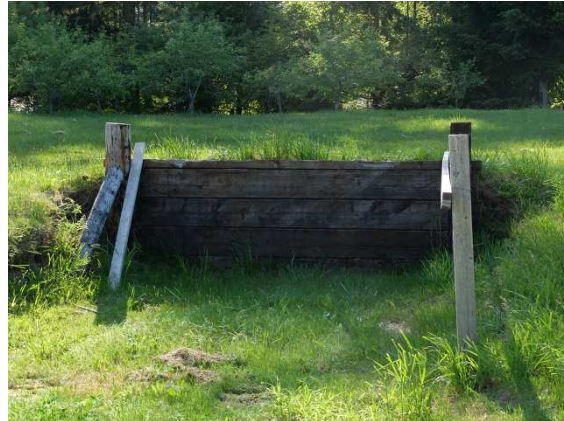
### **No. 11 Loading Dock**

Fig. 16a. Suyematsu loading dock.

Fig. 16b. Manzanita loading dock.

The structure is in good condition.

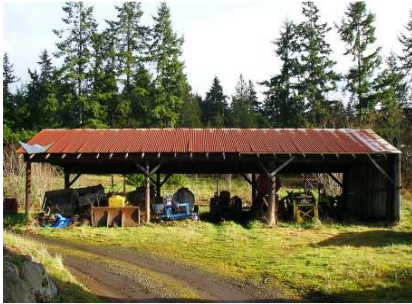
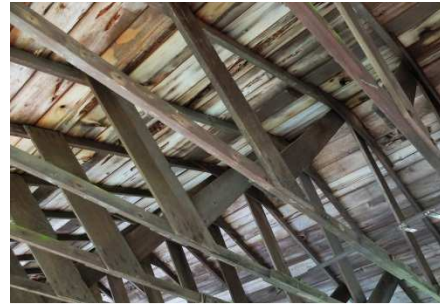
## No. 12 Shed 2

Fig. 17a. West elevation.

Fig. 17c. Roof trusses.

This is an early farm structure, c. 1930-40, has been added onto and repaired over time creating a unique mixture of materials and patinas. It is a contributing structure.

The shed will last another 75 years with regular maintenance.

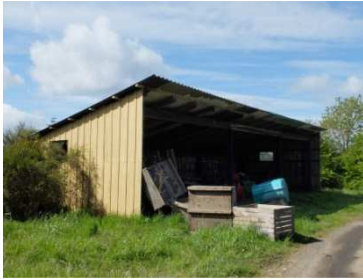
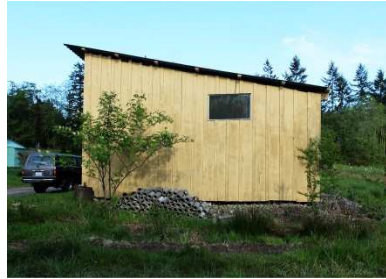
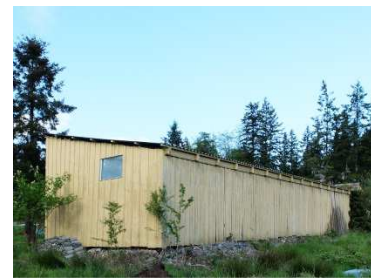
### **No. 13 Shed 3**

Fig. 18a. North elevation.

Fig. 18b. West elevation.

Fig. 18c. SW elevation.

The structure is in good condition and only requires regular maintenance.

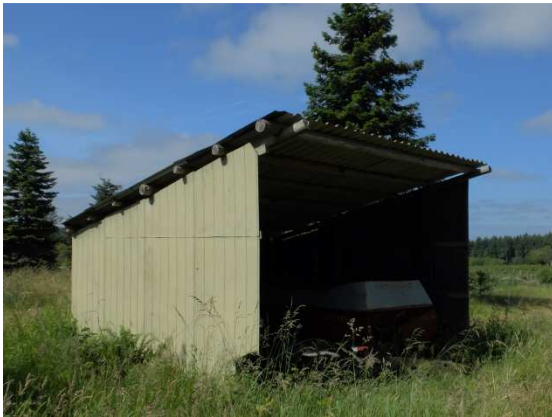
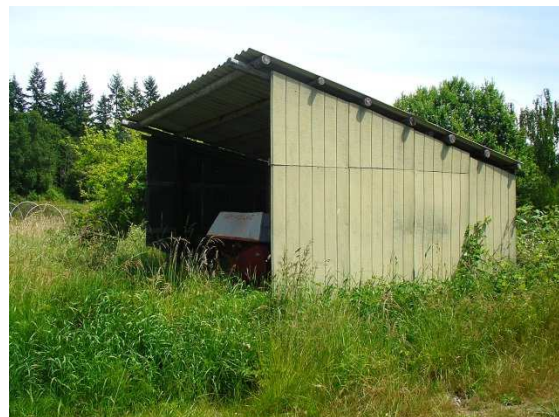
### ***No. 14 Spreader Shed***

Fig. 19a. NE elevation.

Fig. 19b. NW elevation.

The structure is in good condition and only requires regular maintenance.

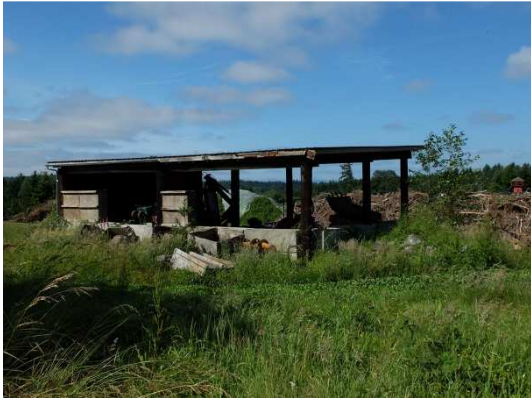
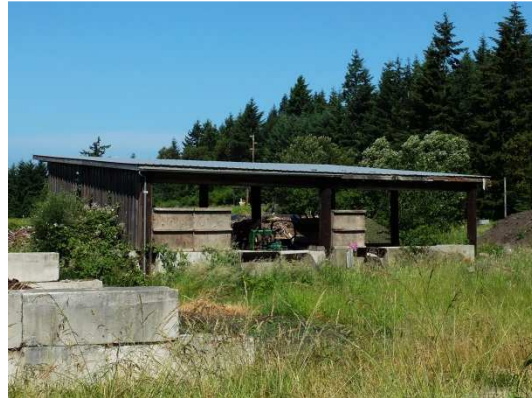
### ***No. 15 Backhoe Shed***

Fig. 20a. NW elevation.

Fig. 20b. SE elevation.

The structure is in good condition and only requires regular maintenance.

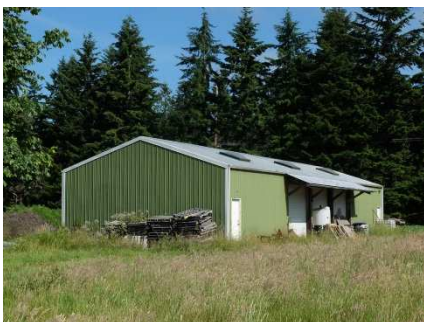
### ***No. 16 Green Shop***

Fig. 21a. SE elevation.

The structure is in good condition and only requires regular maintenance.

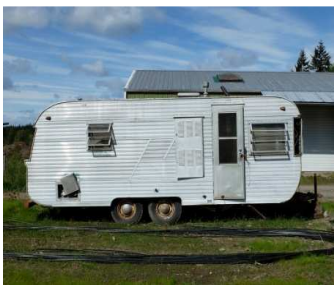
Fig. 22a. Entry elevation.

The aluminum frame is in good condition, but the interior is in need of a complete renovation.

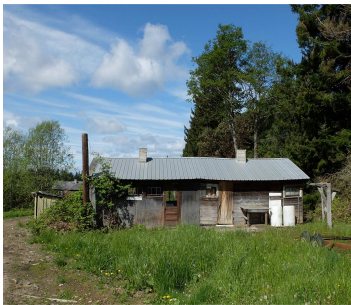
Fig. 23a. East elevation.

The large bunkhouse is in danger of demolition by neglect. With minor replacement of failing structural members and appropriate replacement of siding and roofing, the bunkhouse could once again be used for housing.

- Replace failing structural members.
- Replace siding and roofing as needed.
- Update as needed to meet codes.
- Re-use original materials where possible.

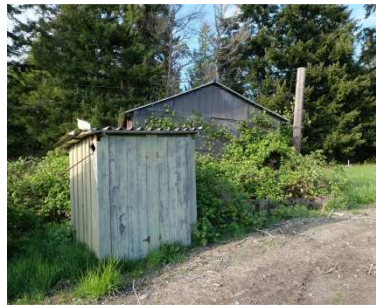
Fig. 23b. Outhouses

Two sets of double outdoor toilets, each with a pair of 2'0" x 6'0" high doors, are located near the large bunkhouse. The toilet sets are 4 x 6 x 7 feet high and made of simple wood framing. The exterior walls are 1 x 8 inch boards and 1 x 2 inch battens and the roofs are made of corrugated metal. Two diamond-shaped holes for a pole have been cut in the walls for easy relocation.

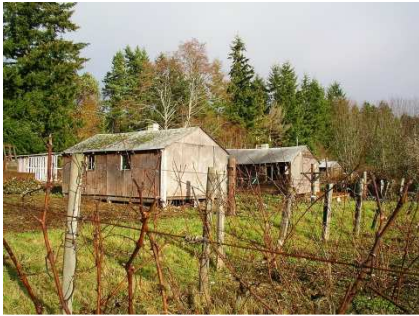
Fig. 24a. SW elevation No.23

The small bunkhouses are in danger of demolition by neglect. With minor replacement of failing structural members and replacement of weather protection in the form of new siding and roofing the bunkhouses can once again house visiting farm workers.

- Replace failing structural members.
- Replace siding and roofing as needed.
- Update as needed to meet codes.
- Re-use original materials where possible.

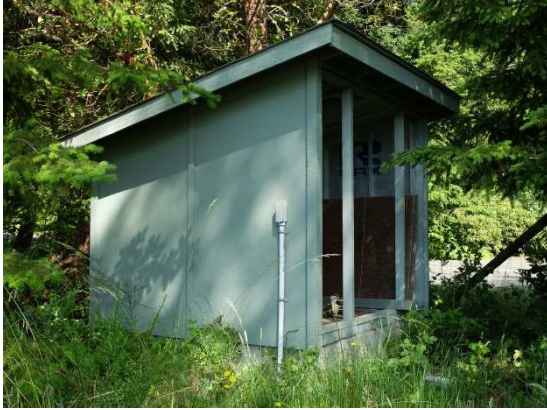
Fig. 25. SW elevation No.25.

Both the well house and the nearby storage shed were built c. 2000.

The well house and shed fall outside of the period of significance and are not contributing structures.

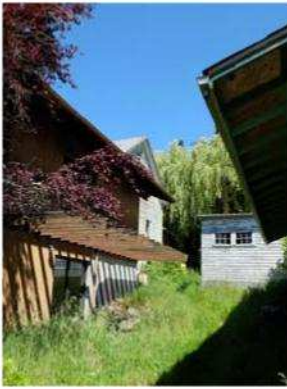
South elevation of house

The house is 1.5 stories and rectangular in plan, with a simple 12:12 slope gable roof oriented north-south. The east side of the house has a covered deck with a hip roof. The total enclosed area is 1680 feet including 300 square feet in the basement. The exterior materials are painted wood shiplap siding, asphalt shingles on the roofs, and wood double-hung windows. In 1971, a concrete block foundation was constructed and the living room windows were replaced with aluminum sliders. At the same time, an addition was built on the west side, with vertical plywood siding, horizontal sliding windows with bronze anodized aluminum frames and a concrete block foundation.

- Replace the aluminum windows in the original section of the house with the original wood windows (restored).
- Replace newer doors with original doors.

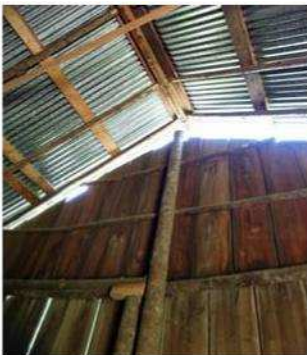
The gable roof barn is 24 wide by 30 feet long, oriented north-south, and is divided into three 10 x 24 feet long bays on the east elevation. The foundation consists of embedded 16-inch diameter treated poles, of various lengths, placed with one on each corner, one at each exterior midpoint and one in the middle for a total of nine column supports. Three large half-round 18-inch diameter pole beams connect the columns in the north-south direction. Logs ranging from 6 to 8 inches in diameter are placed at approximately 2 feet on center and connect the half-round beams in the east-west direction. The logs support 2 x 8 inch and 2 x 12 inch planks which make up the floor of the barn. The north, west and south walls have no openings, but the east side of the barn has two 8.5 x 8.5 feet high sliding wood board doors that can open up two thirds of the eastern wall of the barn. The sliding doors are supported by a 2 x 16 inch by 20 feet long header that spans between 3 columns. The entry to the barn is 8 feet 4 inches clear to the underside of the 2 x 16 inch beam. The sliding doors are fabricated from 1 x 8 inch shiplit boards and the remaining 10-foot panel is made of the same boards laid up horizontally. The walls and roof of the barn are supported by 9 log columns that vary from 6 to 10 inches in diameter. The columns are connected horizontally by 4-inch diameter logs which also serve as supports for the exterior wall assembly. The north, west and south walls of the barn are vertical 1 x 12 inch boards with a 1 x 4 inch batten. The roof rafters are 4 inch diameter logs spaced at 4 feet on center. There are 4 log crossies, located 10 feet clear from the floor that stabilize the roof structure and provide a storage space. The 2-foot wide galvanized corrugated steel roof panels are attached to the rafters.

Wall & ceiling of barn

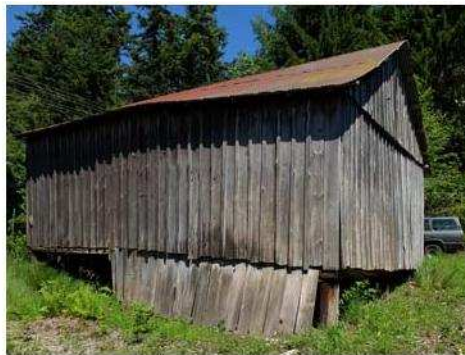
West elevation

The barn is an important structure that is in very poor condition. The building has shifted on its foundation over time and has consequently twisted and deformed some of the pole structures. However, the original basic structural system is intact.

- Replace rotten foundation pole columns and beams need.
- Replace walls and framing as needed and install bracing.
- Reuse materials (such as existing siding, skirting, floor planks and barn doors) whenever possible.

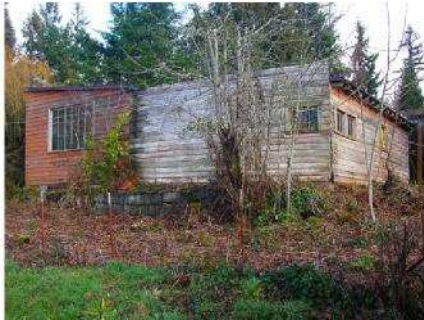
West elevation of workshop

The combination garage/workshop/office structure is located 100 feet southeast of the barn. It is 30 x 44 feet long, oriented north-south, and is divided into two parts, the 20 x 30 feet wide northern garage and the 24 x 30 feet wide workshop area. The garage portion is covered by a shed roof that slopes down at 3:12

from north to south. The roof is supported by 2 x 10 inch rafters spaced 2 feet on center which are covered by 1 x 6 inch boards laid horizontally and nailed to the rafters. The north end of the structure is an open garage area and is 11 feet clear under the three 2 x 12 inch members nailed together to form the built-up beam that spans the 20-foot opening. The east and west walls and the 10-foot long fin wall are typical 2 x 4 inch at 2 feet on center framing that sit on a 14 x 16 inch beam resting on the concrete floor. The south side of the garage has two pairs of 6 x 8 feet high doors that open into the workshop area behind. The east, west and partial north walls are clad with 1 x 8 shiplap boards. The western wall has a 5.5 x 8 feet long fixed window with 18 lights and wood muntins which brings light into the garage area.

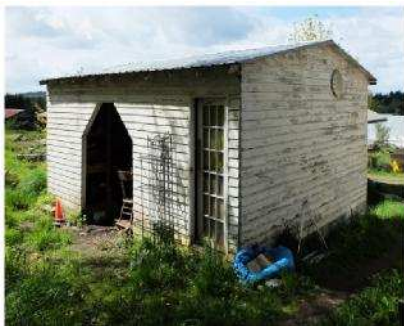
Northeast elevation

This storage building is located 15 feet south of the house. The structure is 16 x 20 feet long, is oriented north-south and has a 2:12 slope gable sheet metal roof. It is constructed with 2 x 4 inch studs at 2 feet on center. The roof is supported by 2 x 4 inch built-up trusses spaced 2 feet on center and covered with 1 x 6 inch boards laid up horizontally. The exterior walls are clad with 1 x 6 inch shiplap wood siding. The east elevation has a 12 x 16 feet deep open storage area with a dirt floor and a 6 x 8 feet high opening on the east. The north third of the structure is an enclosed space with a wood plank floor. The east wall has an 18-light wood door measuring 2 feet 6 inches wide x 6 feet 8 inches high.

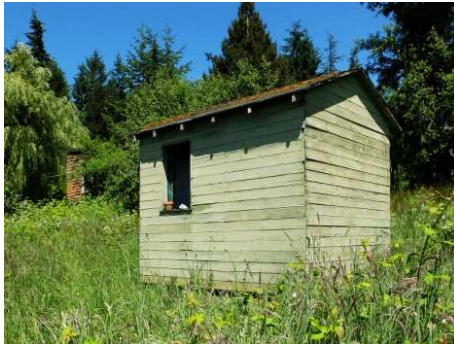
The shower shed is a simple wood frame structure feet 8 x 10 feet long. It is oriented north-south and has a 4:12 slope gable roof clad with asphalt shingles. It is constructed with 2 x 4 inch studs at 2 feet on center. The roof is supported by 2 x 4 inch rafters and cross ties spaced 2 feet on center and covered with horizontal 1 x 6 inch boards. The exterior walls are clad with 1 x 6 inch shiplap wood siding. The door on the north side opens to a room with a 2'8"x2'8" metal shower enclosure and a water heater. The foundation is not embedded into the ground and sits one foot above grade.

Southwest elevation of shower shed

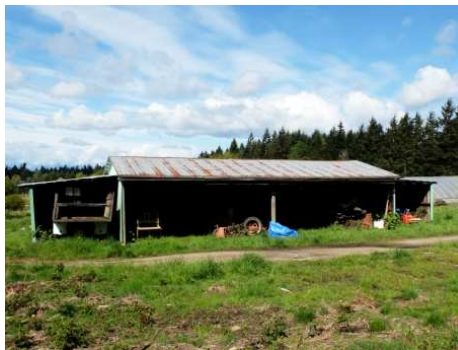
West elevation of Shed 1

The northernmost shed (shed 1) is a half-open structure, oriented north-south. The main 2-bay central space is 48 x 25 feet deep, has a 3:12 gable roof and a dirt floor. The south, west and north walls are made of 1 x 10 inch boards and 1 x 3 inch batten attached to 2 x 4 inch studs at 4 feet on center. The three walls sit on 6 x 6 inch beams supported by regular footings. The gable roof is supported by 2 x 4 inch built up trusses spaced at 4 feet on center. The trusses are supported by two 2 x 12 inch members nailed together to form the built up beams on both sides. The metal roof is attached to 1 x 6 inch boards. The main central bays are flanked on the north and south sides by two identical shed structures (13 x 21 feet deep) that slope to the north and to the south. The 3:12 shed roofs are supported by 2 x 4 inch rafters at 3 feet on center. The metal roofing and the end and side walls of both sheds are similar construction to the central two-bay structure.

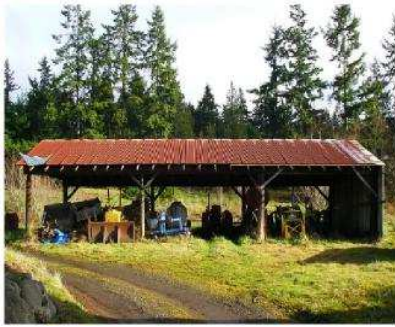
West elevation of Shed 2

The southeastern shed (shed 2) is an open structure, oriented north-south, It is 20 x 48 feet long with a 6:12 gable roof and a dirt floor. The south wall is made of 1 x 10 inch boards and 1 x 3 inch battens. The main structural members are eight assorted poles that create three 16 x 20 foot bays. The gable roof is supported by 2 x 3 inch built up trusses spaced at 2 feet on center. The trusses are supported by two 2 x 12 inch members nailed together to form the built up beams on both sides. Separate footings support the poles. The roof is a palimpsest of historic layers including the original 1 x 6 inch boards, covered with asphalt sheeting, the occasional plywood panel and the most recent corrugated steel roofing.

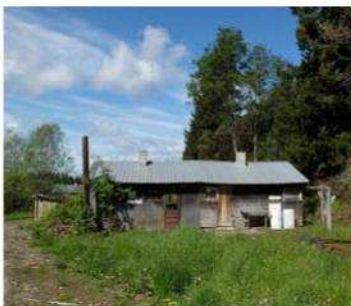
East elevation of bunkhouse

The large bunkhouse or pickers' cabin is located in the northwest of the developed farm structures. The north-south oriented gable roof cabin is 16 x 36 feet long and divided into four roughly equal rooms. It uses typical western framing with 2 x 4 inch studs at 2 feet on center. The roof framing is 2 x 4 inch rafters and 2 x 4 tie members also spaced at 2 feet on center. The exterior walls are made of 4 x 8 feet sheets of particle board nailed on top of continuous horizontal 1 x 8 inch boards. The cabin sits on individual 6 x 6 inch footings, three on the short sides and four on the long sides and down the middle. The walls and the 2 x 6 inch floor joists spaced at one foot on center, sit on two 2 x 6 inch members nailed together to form the built-up beams on both sides. Three of the rooms have a 2 feet 6 inch x 6 feet 6 inch door on the east side. All four rooms have a 4 x 4 foot two-light sliding aluminum window on the west side. The north and south end walls have no openings. The gable roof has a 6:12 slope and has metal roofing on top of asphalt sheeting which is attached to continuous 1 x 6 inch boards attached to the roof rafters. The cabin has two 16 x 16 x 8 inch concrete block chimney stacks located seven feet above the floor.

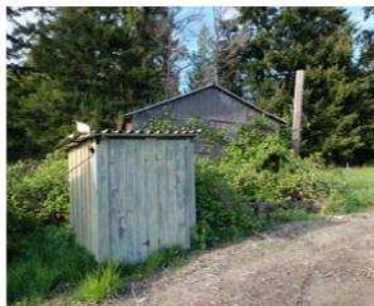
Outhouses

Near the large bunkhouse are two sets of double outdoor toilets, each with a pair of 2 feet x 6 feet doors. The toilet sets are 4 x 6 x 7 feet high and made of simple wood framing. The exterior walls are 1 x 8 inch boards and 1 x 2 inch battens and the roofs are made of corrugated metal. Two diamond shaped holes have been cut in the walls for easy relocation.

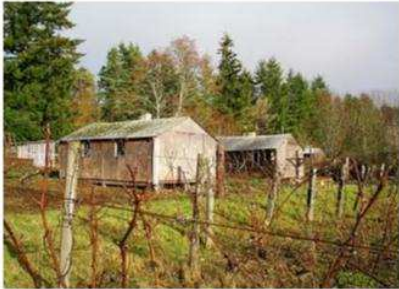
Southwest elevation of bunkhouse

sides. Each cabin has two 2 feet 6 inch wide x 6 feet 6 inch high doors on the east side and two 2x2 foot four light fixed windows (No.22 has one fixed and one aluminum 2x3 slider). The north and south end walls have no openings. The gable roofs have a 6:12 slope and have asphalt shingles on top of the continuous 1 x 6 inch boards attached to the roof rafters. There is a 16 x 16 x 8 concrete block chimney stack.

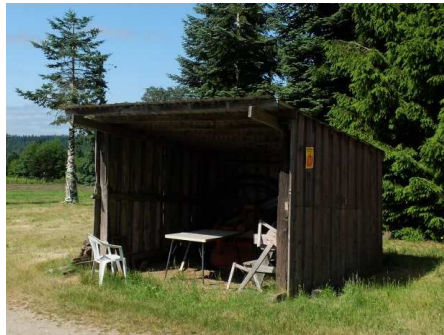
Front and side of berry shed

This Berry Shed (No. 29) is 10 x 10 feet and walled on three sides with vertical 1 x 6 boards and battens attached to 3 x 6 horizontal members located at the top bottom and middle of the wall. The 2:12 metal panel shed roof slopes up west to east and is held up by four quarter log portion posts set in each corner which support a structure of 2 x 4 joists spaced 2 feet on center.

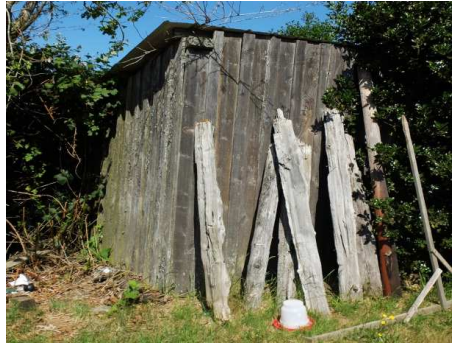
SW elevation

This Berry Shed (No. 30) is 10 x 10 feet and walled on all sides with vertical 1 x 10 boards and 1 x 4 battens attached to 3 x 6 horizontal members located at the top bottom and middle of the wall. The north wall has a 5 foot opening at the mid-point of the wall. The 2:12 metal panel shed roof slopes up west to east and is held up by four quarter log portion posts set in each corner which support a structure of 2 x 4 joists spaced 2 feet on center.
